# Overview of some major incidents in radiotherapy and their consequences

Hamish Porter

BIR - Radiotherapy Errors and Near Misses September, 2012

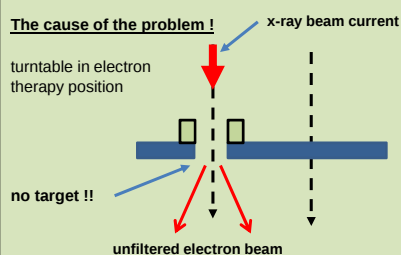
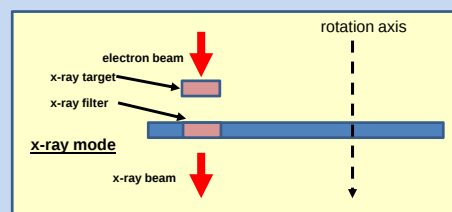
**The cause of the problem !**

turntable in electron therapy position

This action was to REMOVE THE KEY CAP OF THE "UP CURSOR (R) KEY and use insulating tape to keep the key contacts in the open switch position. An engineer could be contacted if they required help with this procedure.
